# Single Survey

survey report on:

| <b>Property address</b> | 21 Dalrymple Drive<br>Irvine<br>Ayrshire<br>KA12 0PE |

| <b>Prepared by</b> | DM Hall |

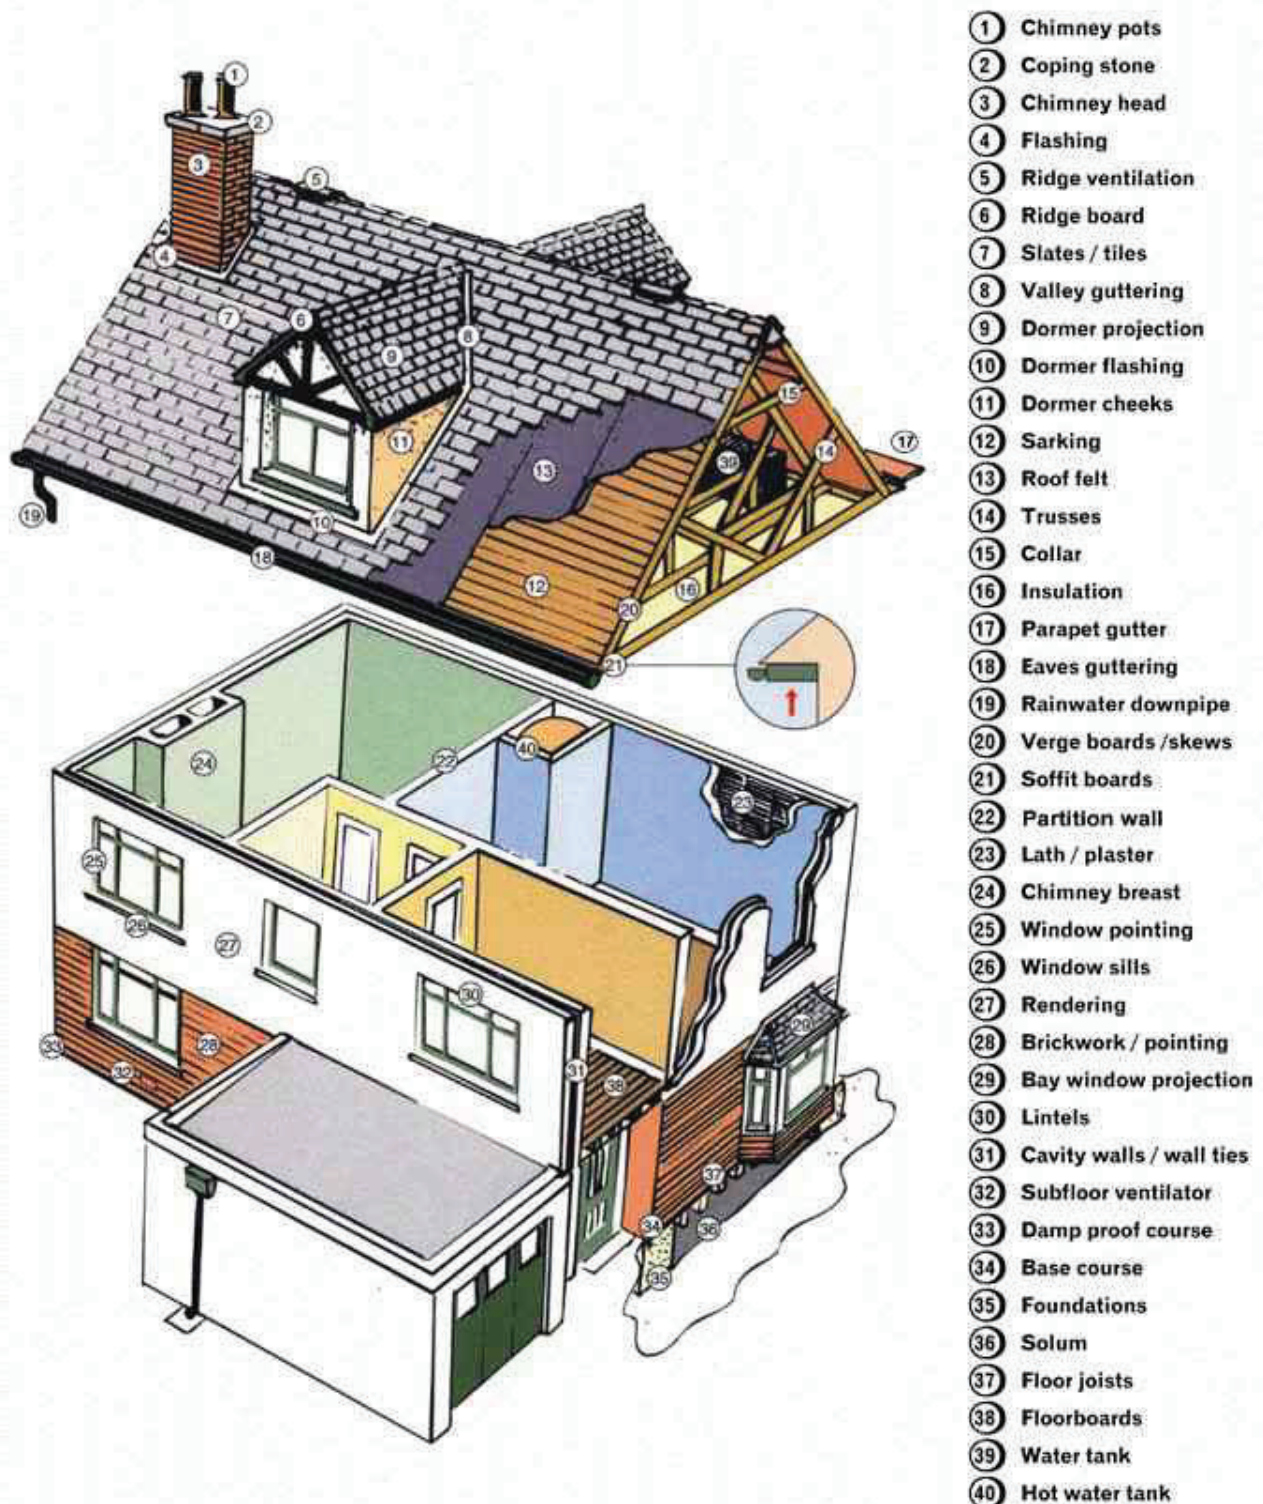
## Sectional Diagram showing elements of a typical house

Reference may be made in this report to some or all of the above component parts of the property. This diagram may assist you in locating and understanding these items.
